PRESERVATION ASSESSMENT OF THE LYNNHAVEN HOUSE CEMETERY, VIRGINIA BEACH, VIRGINIA

Chicora Research Contribution 554

Prepared By:
Michael Trinkley, Ph.D.
and
Debi Hacker

August 2013

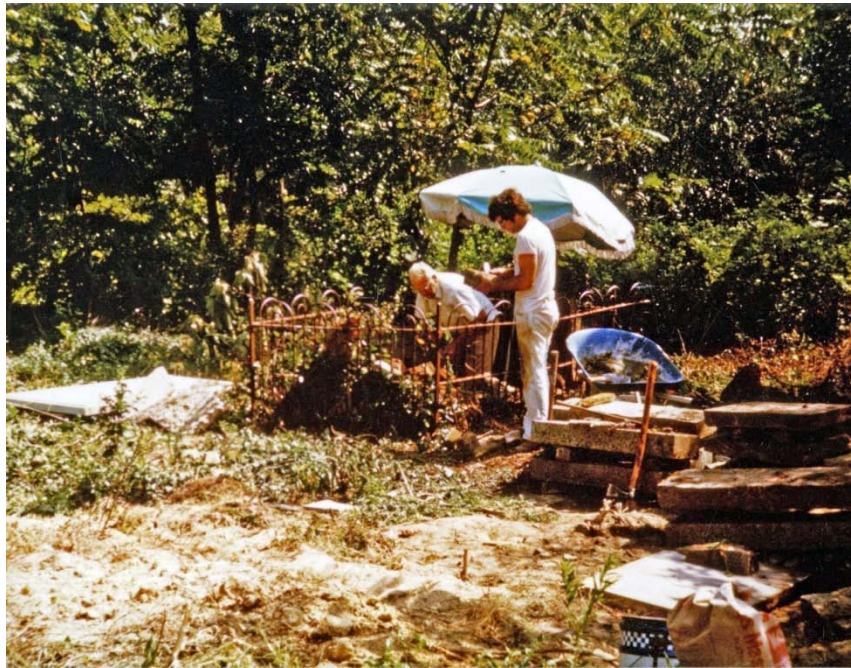
Figure 11. Mason restoring the box tomb of Eliza J.S. Walke in July 1975 (City of Virginia Beach Department of Museums).

A photograph from the same July 1975 set shows a mason and his helper "restoring" the brick box tomb (Figure 11). The other tombs have been stacked up to the south and appear to be waiting their restoration.

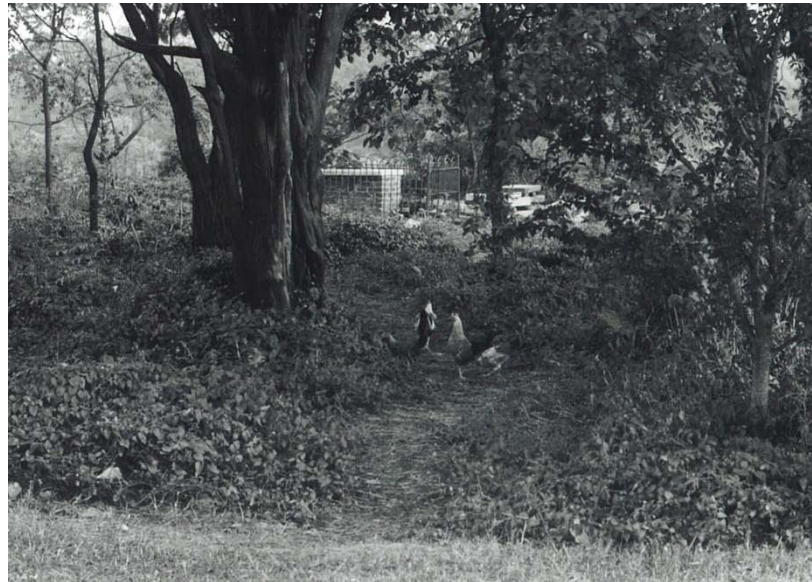
Figure 12. August 1975 photograph of the cemetery showing that the brick box tomb had been restored, but work had not yet begun on the other monuments (City of Virginia Beach Department of Museums).

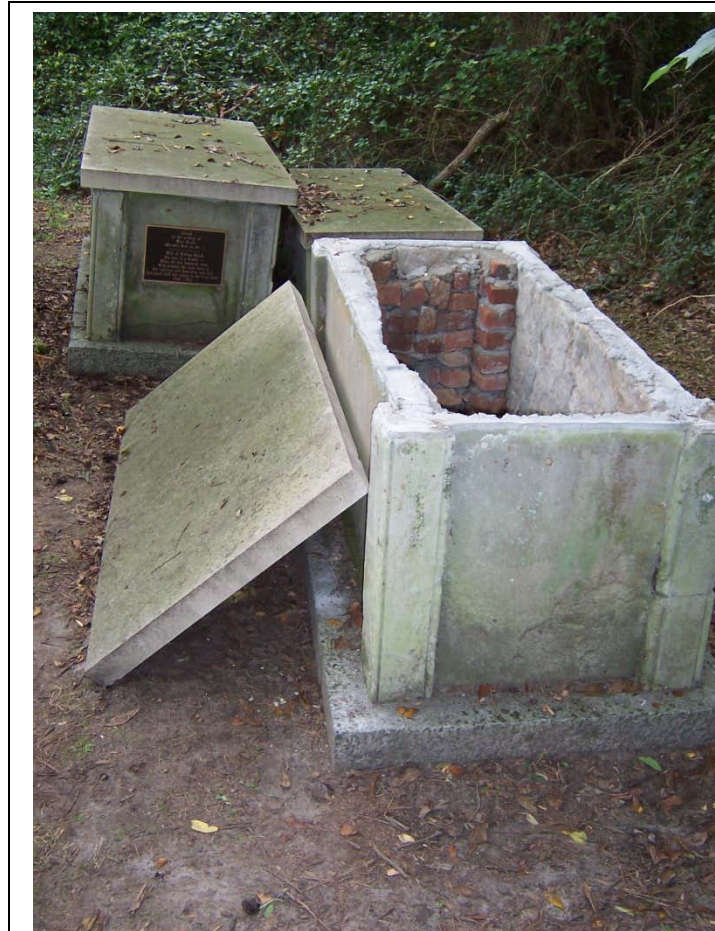
Figure 16. Vandalized tomb of William Boush looking east, October 2007.

(Figure 16). We have noted that the effort to look inside box tombs is rather common since many believe the coffin is within the box, not buried below the box.

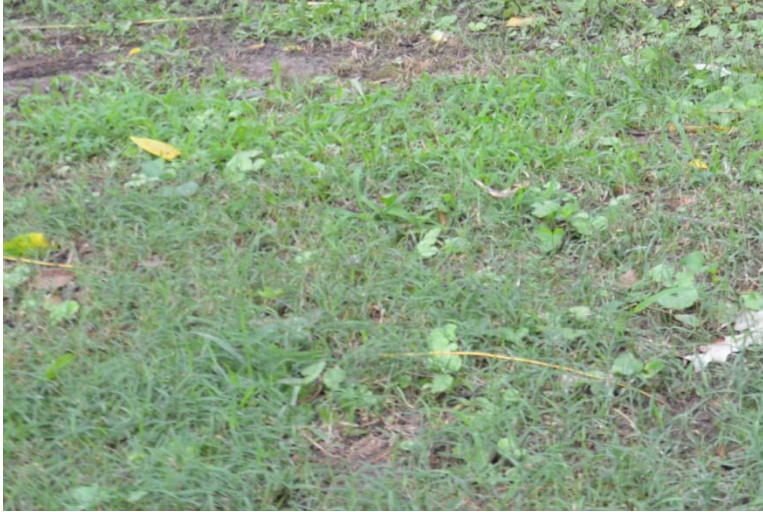
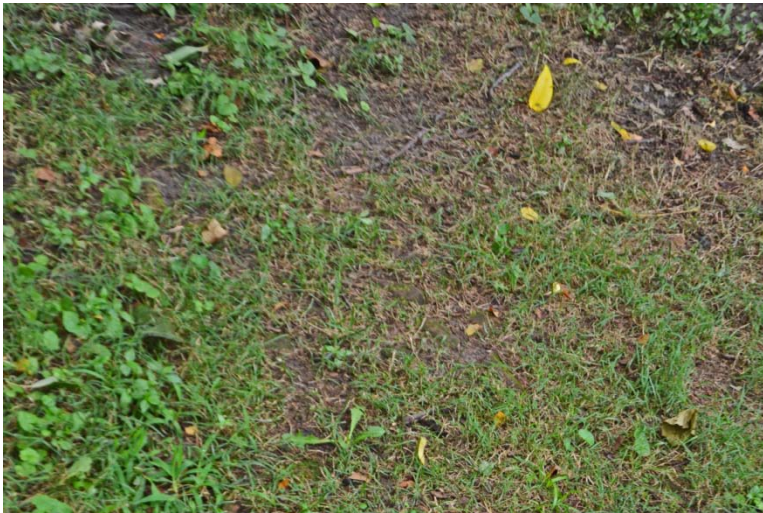
Although the cemetery is dominated by "grass" it is composed almost entirely of different broadleaf weeds with some Bermuda turf. The invasion of broad leaf weeds is especially noticeable (Figure 24). Because of the shade the turf is sparse, with many areas of open soil, especially around the tombs.

Figure 24. Sparse, weedy turf around the cemetery.

to a variety of heights, and has a broad range in color. It is not attractive and it requires above average mowing in order for the turf to appear "neat." Many cemeteries cannot easily afford this additional maintenance.

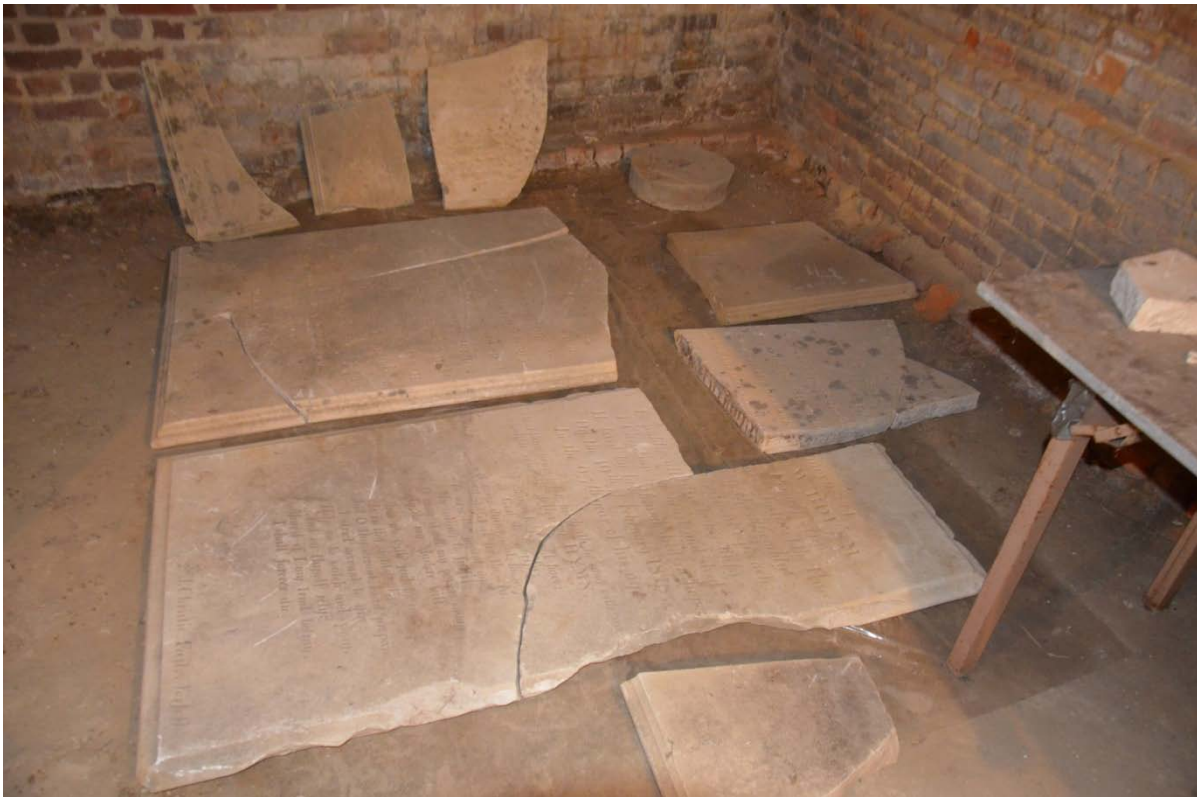
The fragments of the broken ledgers from the cemetery are being stored in the locked Lynnhaven House basement. This provides safe and secure storage and the City has even placed plastic under the stones to minimize their uptake of ground moisture. This storage location is satisfactory.

Figure 28. Example of ledger stones stored in the house basement.

Care must be taken, however, to prevent damage to the stones should repairs or other maintenance be required in the basement.

Storage of damaged ledgers in the house basement is satisfactory, although care must be taken to prevent additional damage during house maintenance activities.

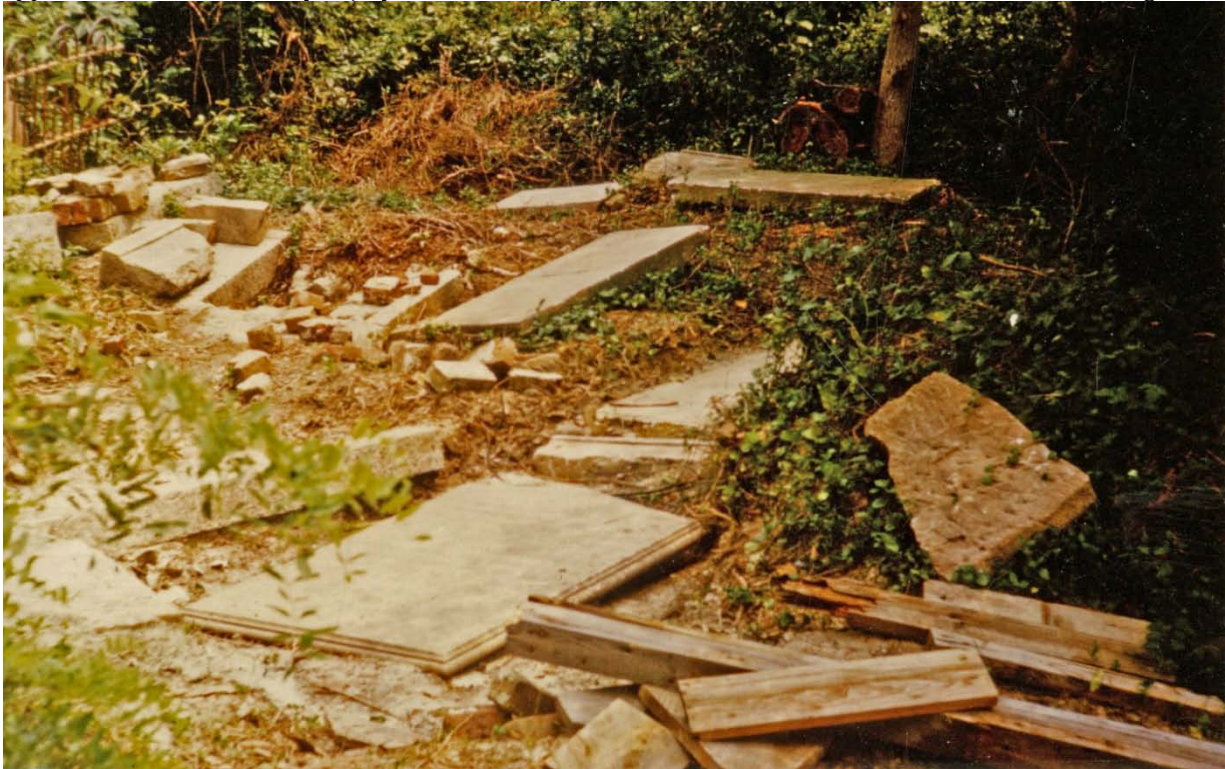
Appearance of the cemetery in July 1975 showing that the William Bosch monument was not standing:

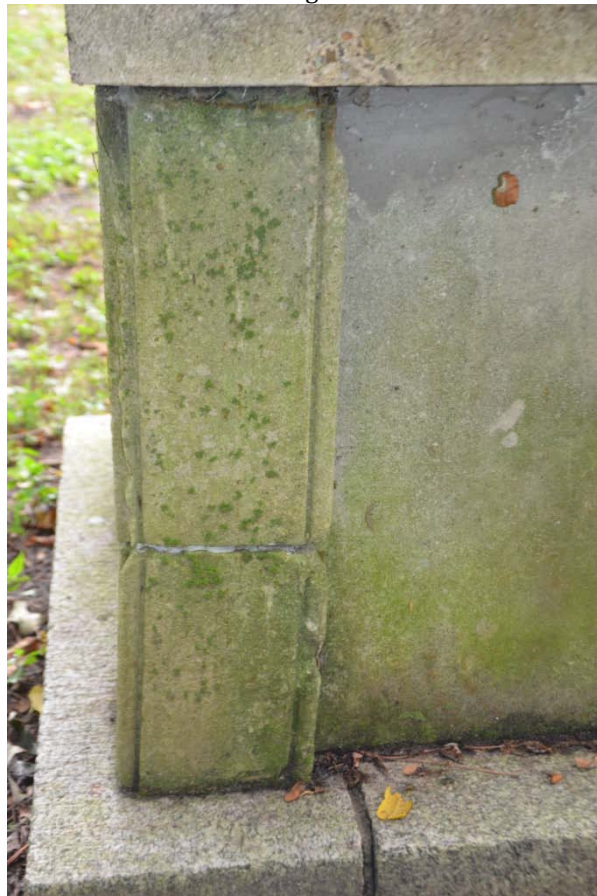
Old break on southwest leg:

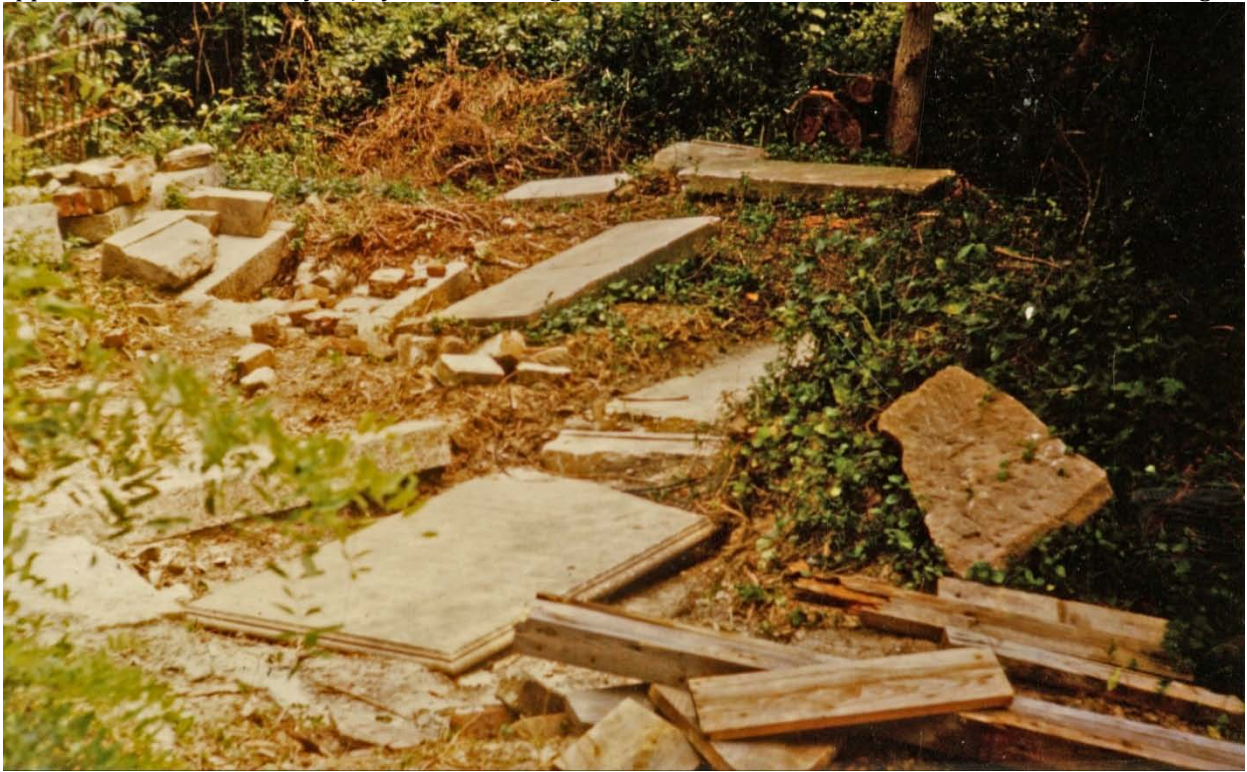
Appearance of the cemetery in July 1975 showing that the William F.W. Bosch monument was not standing:

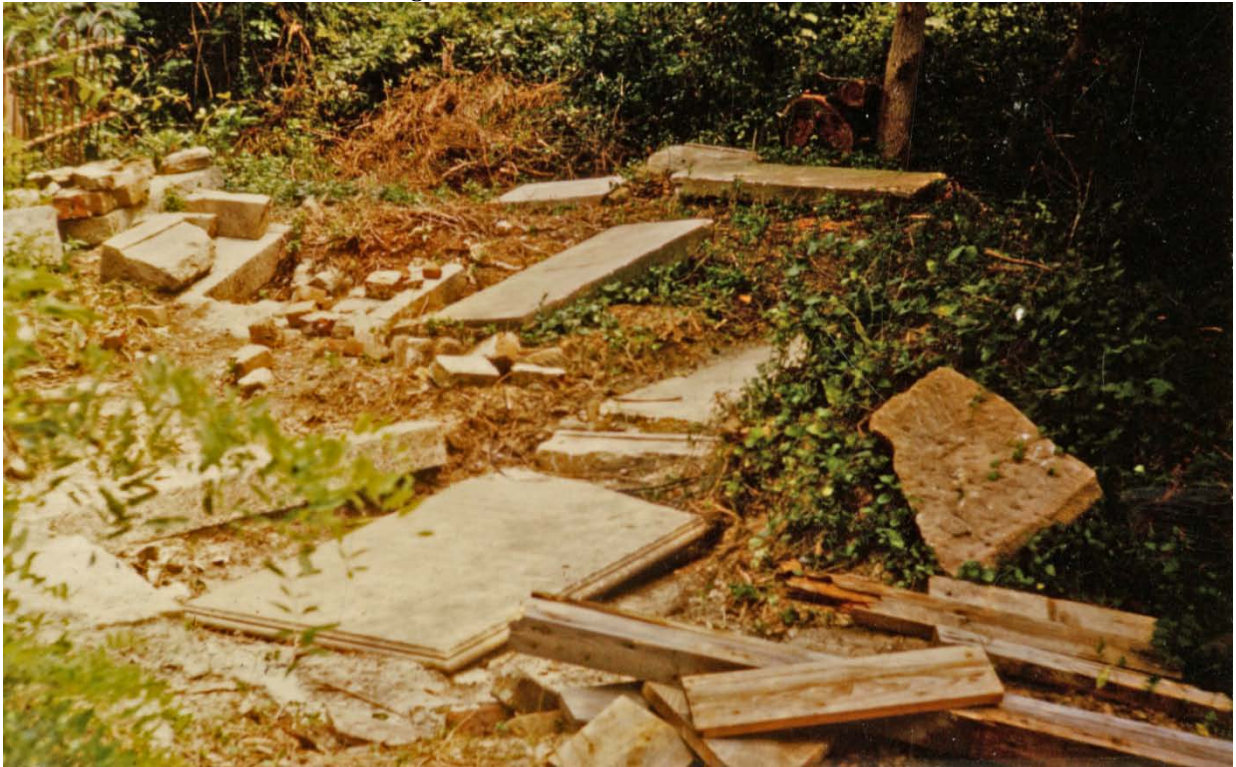
Remnants of William F.W. Boush ledger:

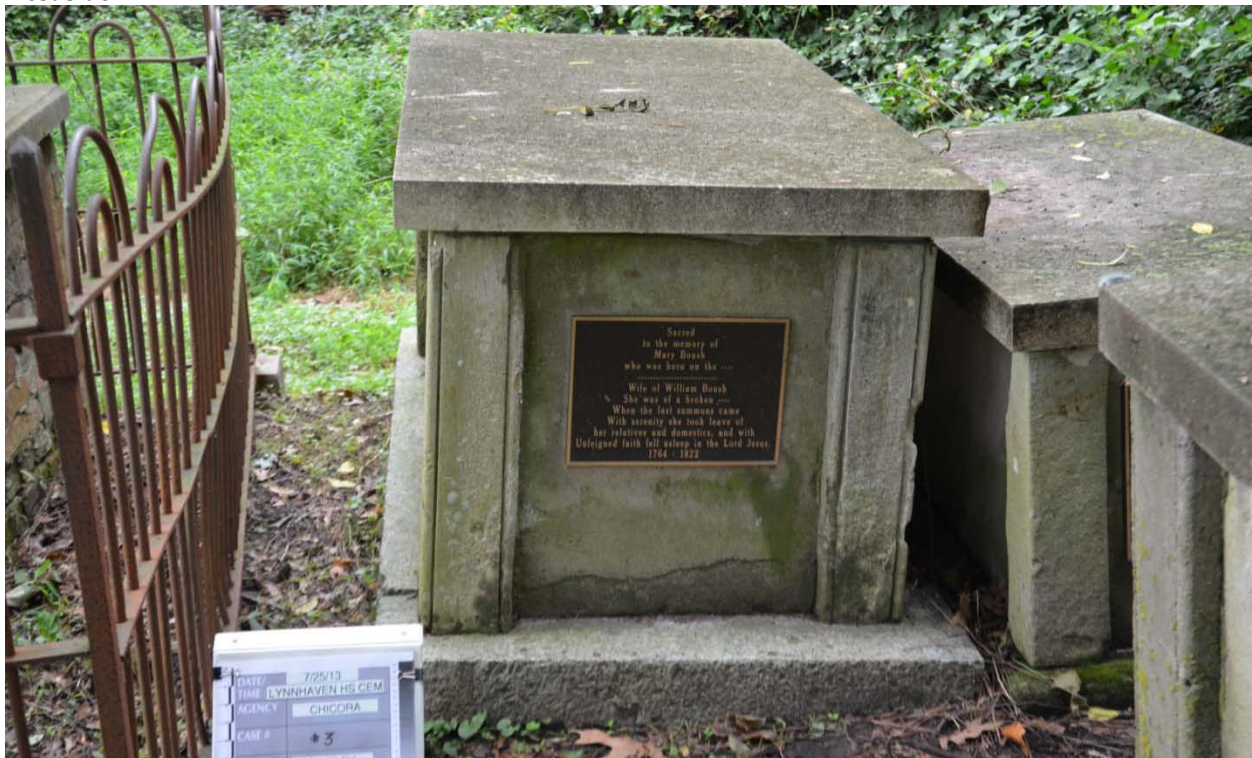
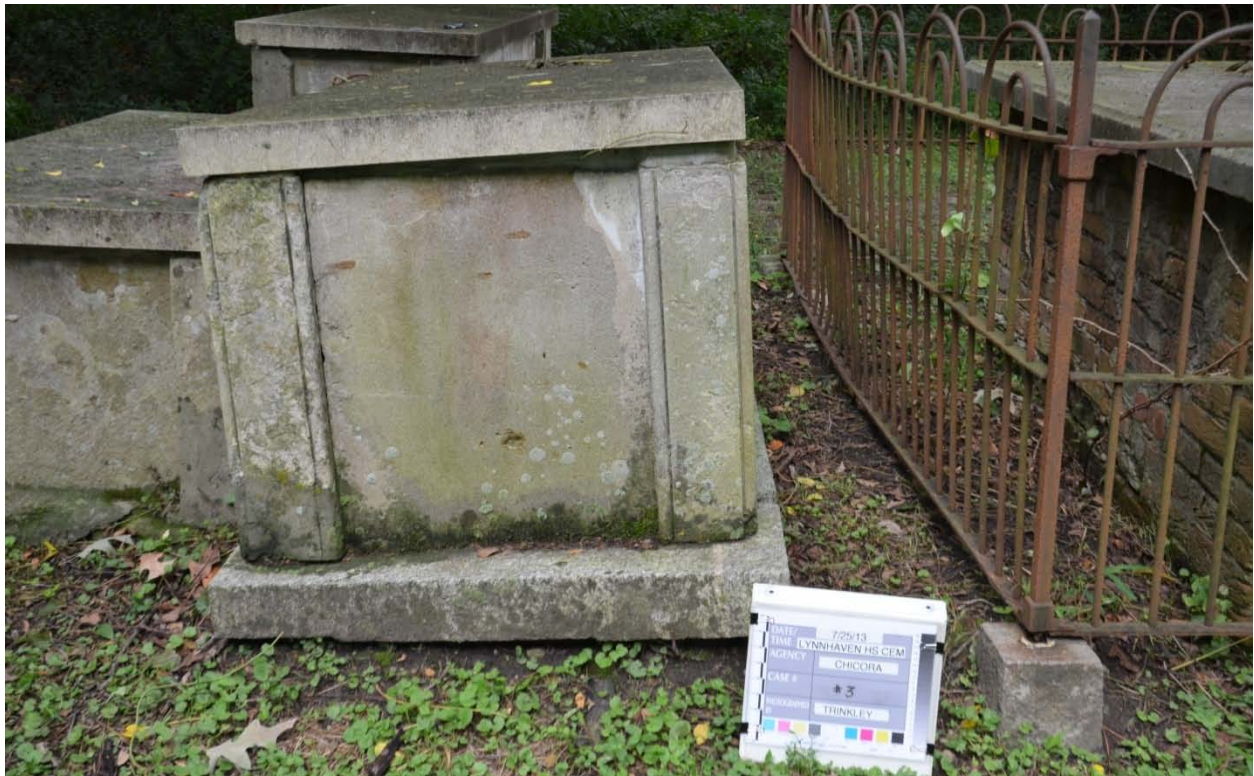
Marker 3, Mary Boush

At a minimum, we recommend that this condition report and associated photographs be used for yearly monitoring to verify that there is no significant change in condition that might warrant treatment options to be reconsidered. This monitoring may be done by staff, but should be reviewed by a stone conservator. Of particular concern is the crack in the north side of the box panel.

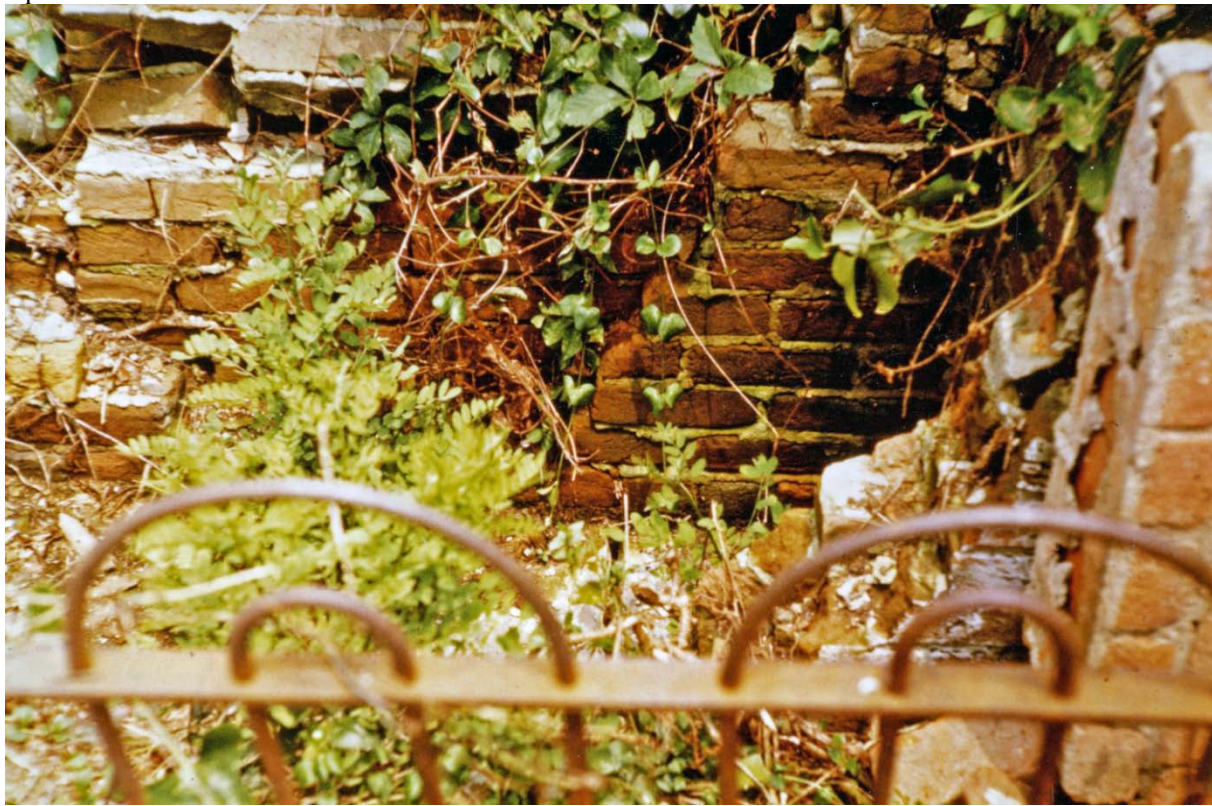
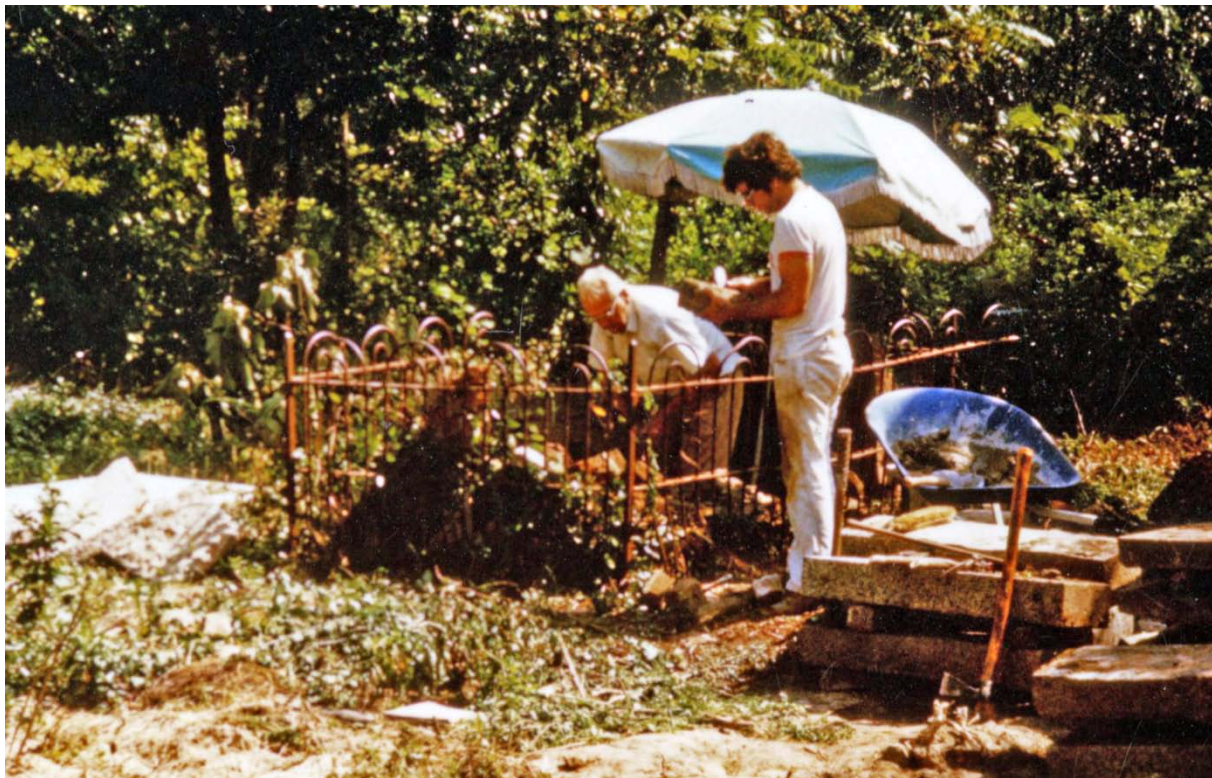
Appearance of the Eliza J.S. Walke monument in July 1975 showing the condition of the remnant box and repair efforts:

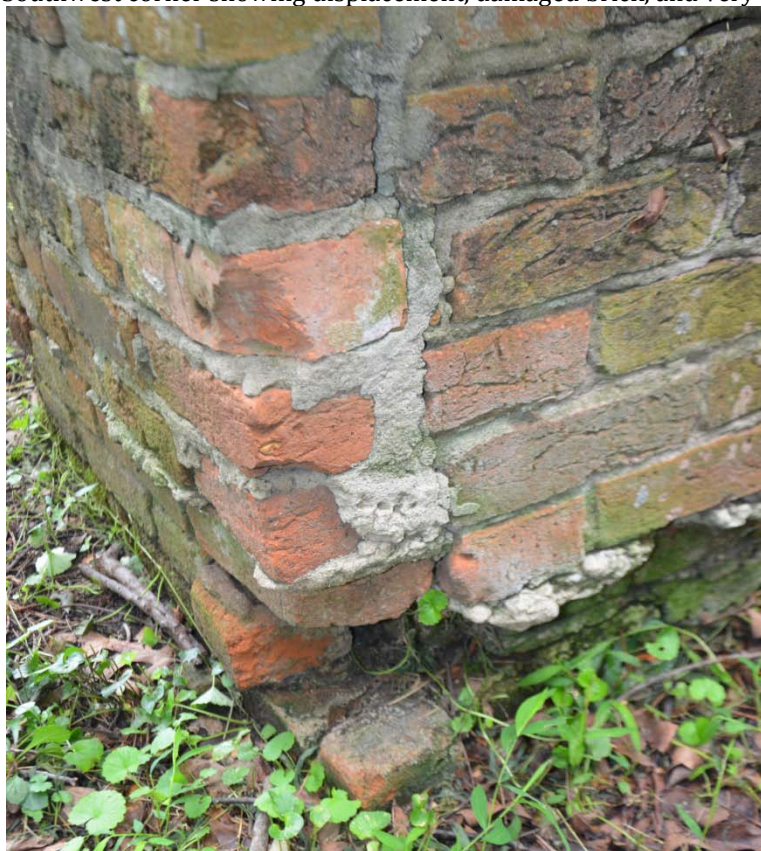
Southwest corner showing displacement, damaged brick, and very poor workmanship:

It is almost certain that the south wall will require repair within the next 2-3 years and this work should be performed prior to any additional damage to the box. The repair work should use either lime putty (if the work is conducted allow at least six months prior to freezing weather) or a 1:2.5 mix of NHL 3.5 and sand. Both have low compressive strength because of their high lime content and would be appropriate for the soft brick of the box.

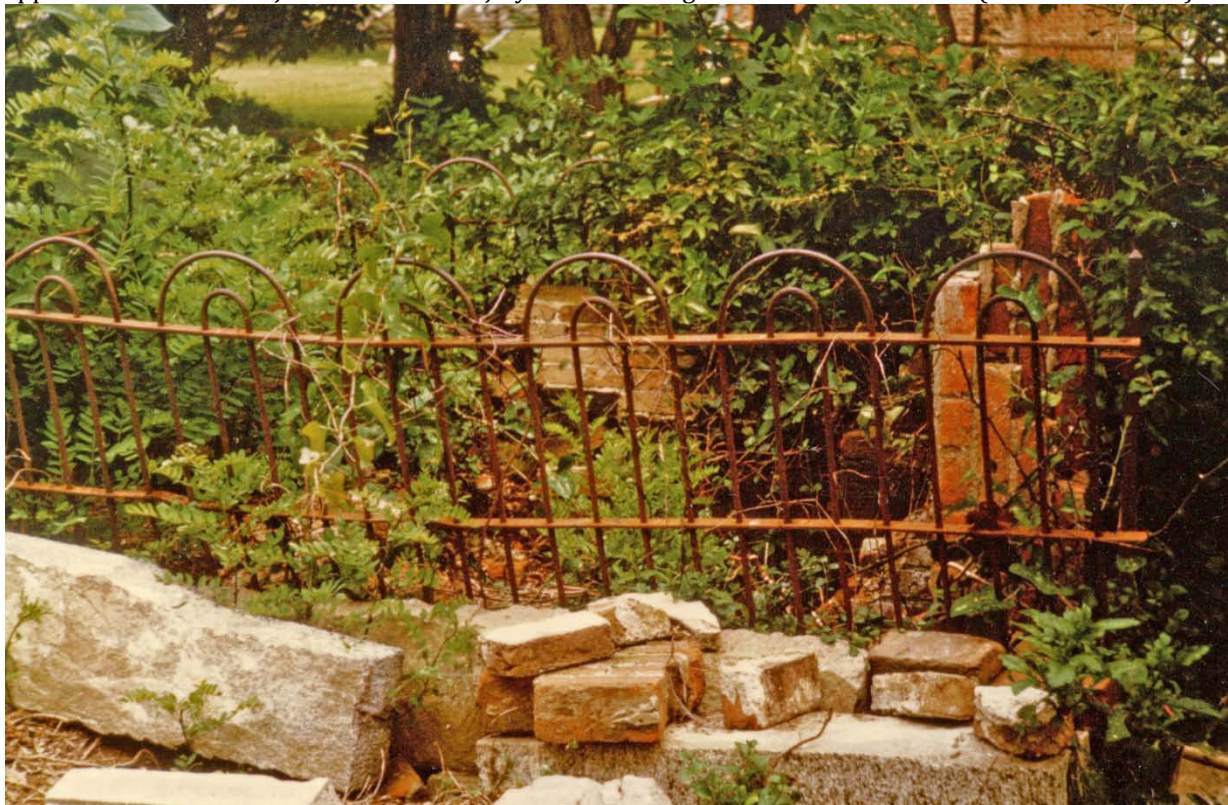
Appearance of the Eliza J.S. Walke fence in July 1975 showing its condition at the time (view to the north):

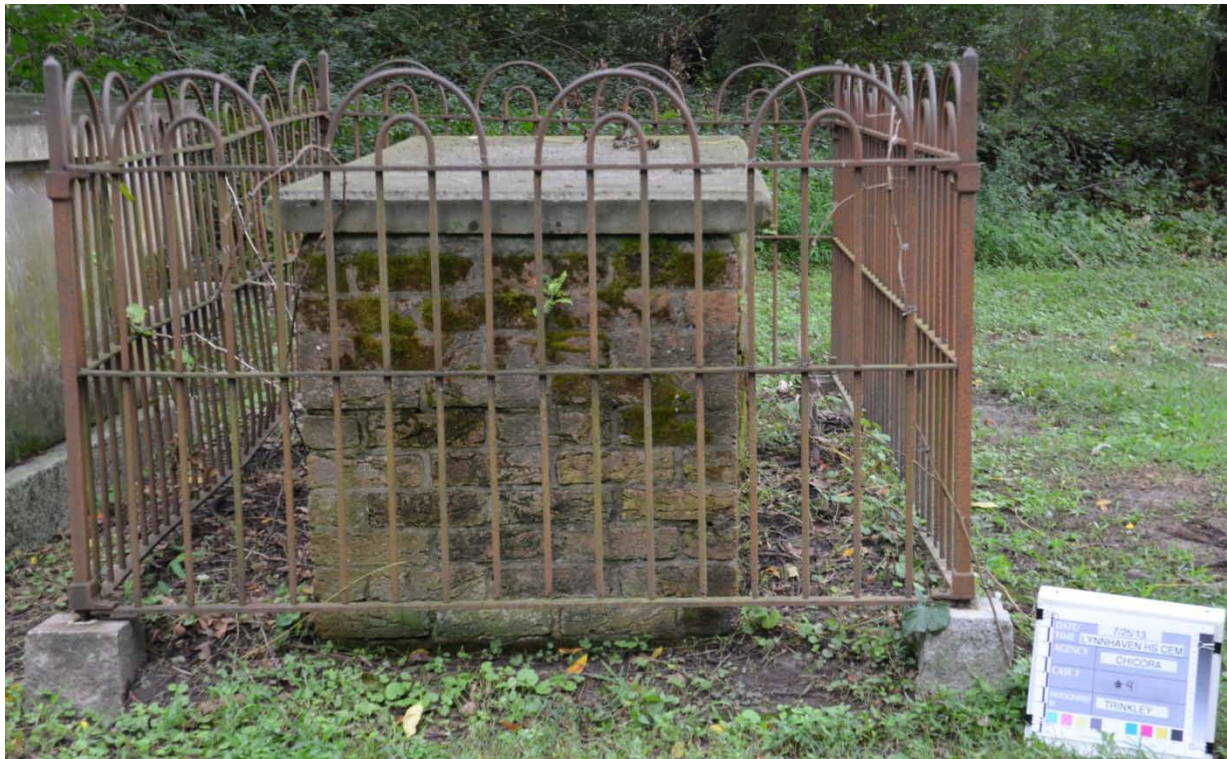
East side of fence:

The fence is stable and no treatments (other than the maintenance actions outlined above) are recommended.

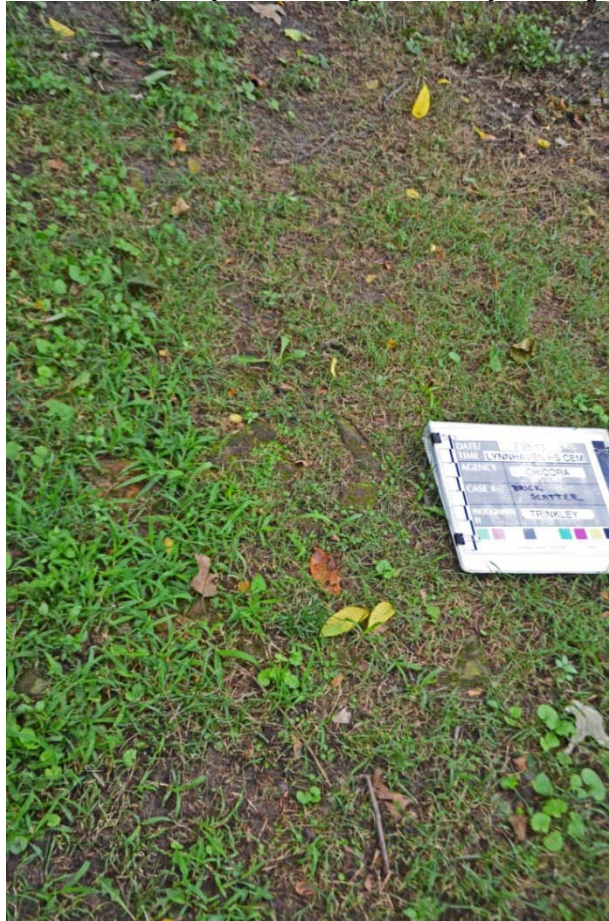
Appearance of the brick mound indicating the presence of grave 5 today, looking west:

If remains of the box cannot be found, we recommend that the archaeological investigations continue until the grave shaft is clearly identified. After full documentation it would be possible to create a suitable box surrounding the grave shaft to achieve the same goal as above.

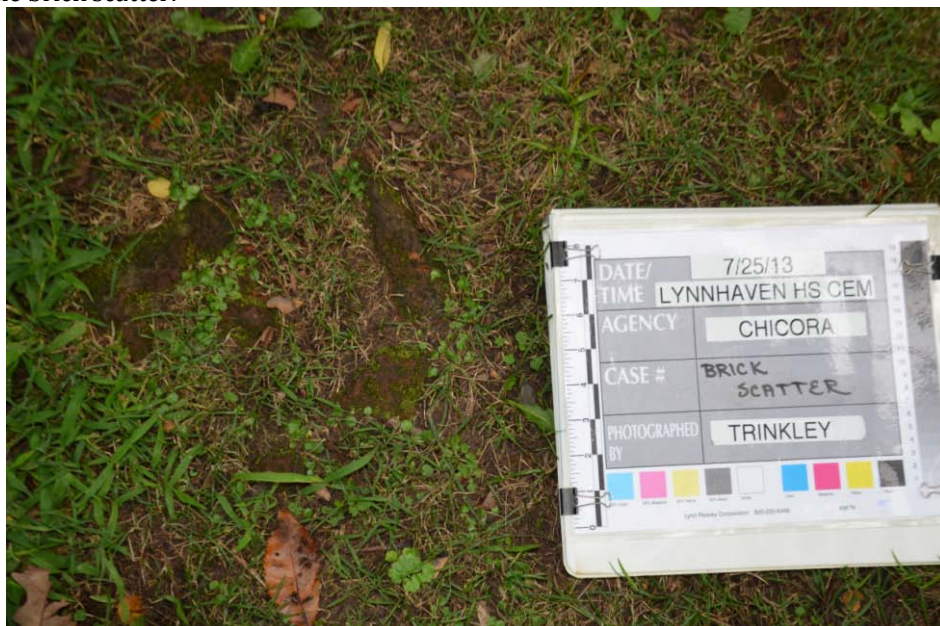
Close-up of the brick scatter:
